Manhole Inspection Summary

Manhole # S49CC_063MH

Insp Date: **6/16/08 9:45 AM**

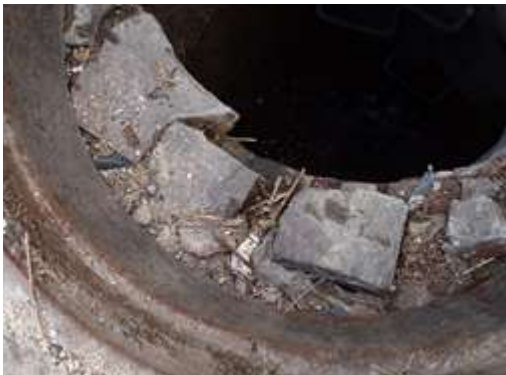
Defect 2

Condition: ☐ Sound ☐ Cracked ☐ Root Intrusion ☒ **Loose Brick** ☐ Deteriorated

loose bricks

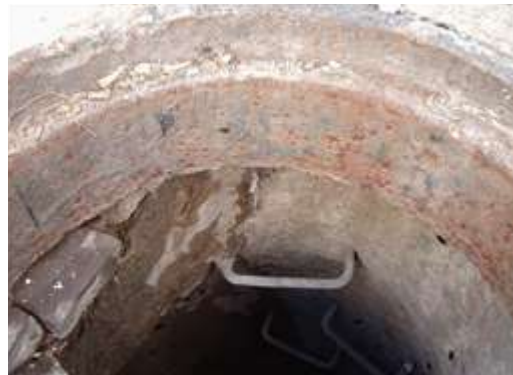
Defect 1

Infiltration: ☐ None ☐ Joint ☐ Cracks ☒ **Mortar** ☐ Roots ☐ Wall

infiltration

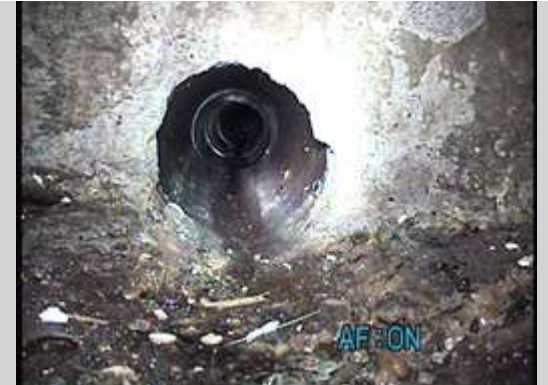
12 O'Clock Outflow

8 in. Circular Gravity Sewer
Pipe Out @ 12 O'Clock

Infiltration: **None** Pipe Seal Cond: **Sound**
